STRUVITE REMOVAL FROM HEAT EXCHANGER

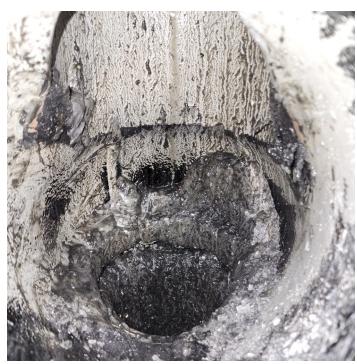
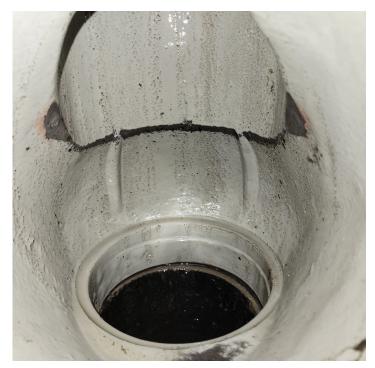
A Midwest wastewater treatment plant was experiencing struvite buildup in their heat exchanger as well as the 62' of 6'' piping. Struvite not only reduced heat transfer inside of the heat exchanger, but also reduced flow! The struvite also prevented various 6'' check valves and 6'' plug valves from being able to close and seat properly.

Struvite had restricted flow and heat transfer in a heat exchanger, 62' of 6'' piping and various check/plug valves. The various valves were unable to close or seat correctly.

The solution was **RYDLYME**! The system was flooded with 330 gallons of **RYDLYME** and water. **RYDLYME** was circulated throughout the system and the results are as expected - struvite is no match for **RYDLYME**! The staff of the wastewater treatment plant are very happy with the performance and safety of **RYDLYME**.

(1) 330 gallon tote of **RYDLYME** and water were circulated throughout the struvite ridden piping and heat exchanger system.

After the **RYDLYME** cleaning, the plant was able to close and seat the various valves correctly and optimal flow and heat transfer was returned to the equipment!
