STAINLESS STEEL PIPELINE CLEANING

A pulp and paper mill was experiencing 1" calcium carbonate build up in a 3" stainless steel pipeline which connected to a tile dissolving tank. After numerous, dangerous and time consuming hydro-blasting attempts, an alternative solution was sought out.

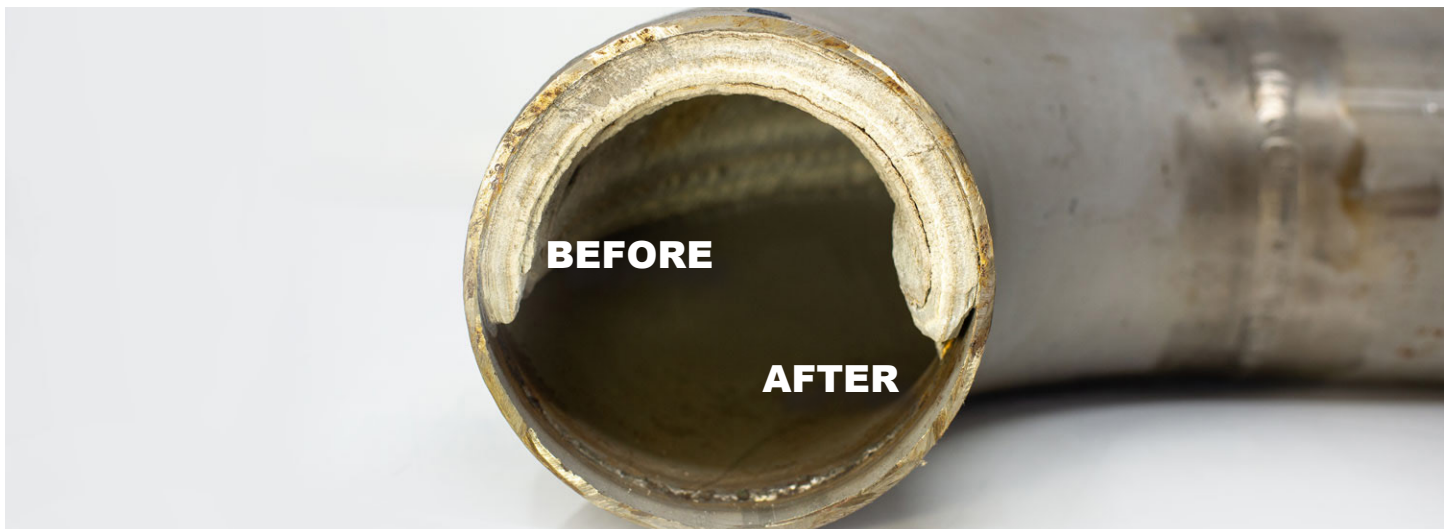
After 5 hours of circulation, the once scale ridden pipeline was returned to its full 3" inside diameter! The mill was now able to get a healthy, steady flow out of the end of the pipeline versus a small trickle before the cleaning!

A total of 1320 gallons of **RYDLYME** was circulated through the stainless steel pipeline for 5 hours.

The stainless steel pipeline was returned to bare metal! No longer was the mill experiencing a slow trickle but rather a powerful, steady flow! The mill is now implementing a preventative maintenance program to make sure this issue does not return!
