AUTOMOTIVE AIR COMPRESSOR CLEANING

A Midwest automotive manufacturer was experiencing issues on their Ingersoll-Rand air compressor. After inspection, the main issue was water scale build up within the equipment. The inlet water temperature before the **RYDLYME** cleaning was 80° and the outlet air temperature was 160°.

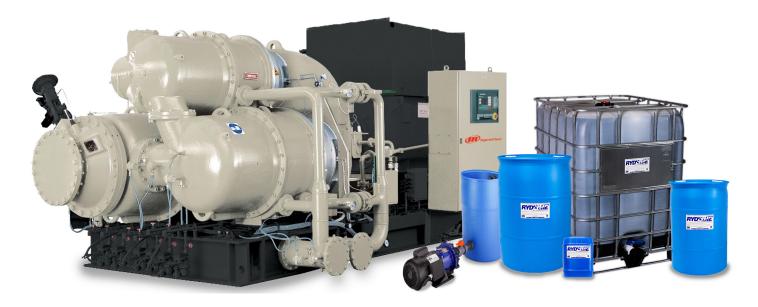
Water scale was creating cooling issues on an Ingersoll-Rand air compressor at a Midwest automotive manufacturer.

140 gallons of **RYDLYME** was circulated through the system for 3 hours. After a water flush, the air compressor was returned to service. The outlet air temperature was now 110°, dropping an incredible 50° and bringing the temperature differential down to only 30°! The plant personnel were amazed at the amount of temperature drop! With the dramatic improvement in efficiency, the plant was convinced to then use **RYDLYME** clean other pieces of water operated equipment including their condensers!

140 gallons of **RYDLYME** was circulated for 3 hours with a water flush after the **RYDLYME** cleaning was completed.

After the **RYDLYME** cleaning, the air temperature was dropped from 160° to 110°, dropping an incredible 50° and bringing the temperature differential down to only 30°!
