A Western Steel Mill was facing very high temperatures on three of their 450 HP Trane centrifugal air compressors. The culprit was water scale deposit covering the surface area of the cooler's tubes. Fortunately, the client found a solution in the biodegradable descaler, **RYDLYME**. Utilizing 35 gallons of **RYDLYME**, the descaler was circulated for 4 hours via a 350 GPM pump using flexible hoses and camlock adapters.

## CHALLENGE

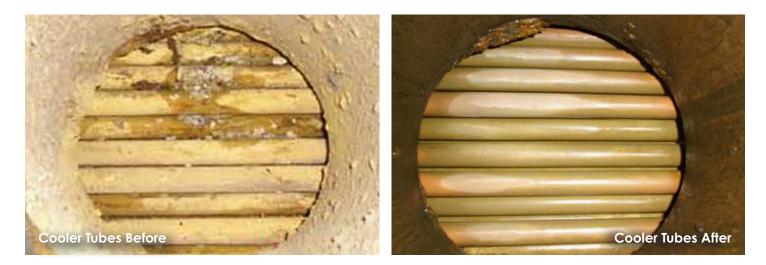
The personnel were extremely impressed with the **RYDLYME** cleaning results! After the cleaning, the cooler tubes were inspected and looked brand new. **RYDLYME** was able to dissolve all water scale from the tubes as well as drastically reduce the temperatures. Personnel reported a 30° temperature drop after the **RYDLYME** cleaning. 'Although only 35 gallons were utilized, the improvement was significant due to densely packed tubes and tendency for water channeling'' - Plant Engineer.

Thick water scale deposits had accumulated within three sets of compressor tubes at a Western Steel Mill.

35 gallons of **RYDLYME** was circulated via a 350 GPM pump with flexible hoses and camlock adapters for 4 hours on each.

After the **RYDLYME** cleaning, personnel had reported a 30° temperature drop and were pleasantly surprised with the quick circulation time!
