CASE STUDY

DISTRICT WWTP CENTRIFUGE CLEANING

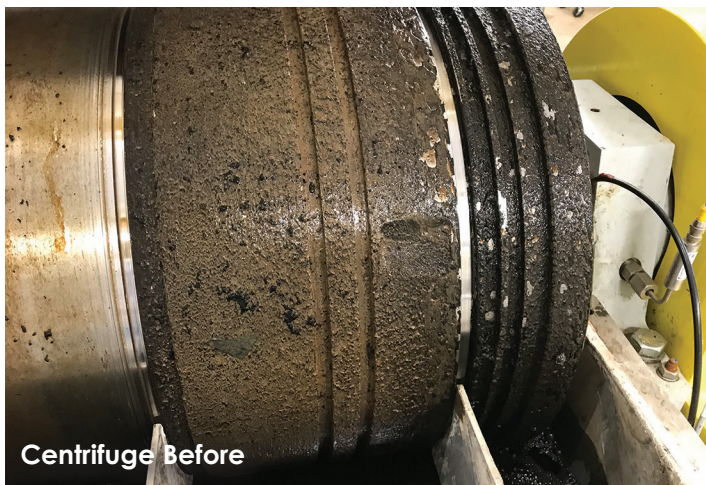
Centrifuge Before

Thick deposits of struvite had accumulated on numerous centrifuges at a district wastewater treatment plant.

A 20% solution of **RYDLYME** was added to the centrifuge basin and the centrifuge was set to 5RPM to rotate for 16 hours.

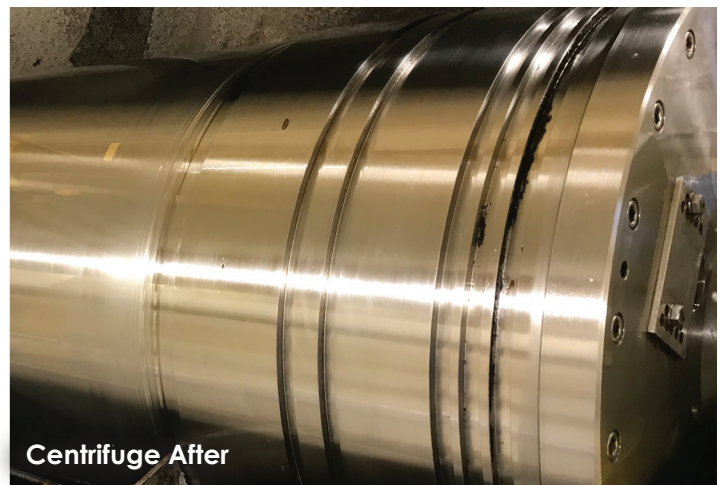
Centrifuge After

The wastewater treatment plant personnel were extremely impressed with the **RYDLYME** cleaning results! After the cleaning, the centrifuge looked brand new. **RYDLYME** was able to remove buildup from areas/crevices that were utterly impossible to access via mechanical cleaning methods.
