# CASE STUDY

## WWTP DIGESTER LINE CLEANING

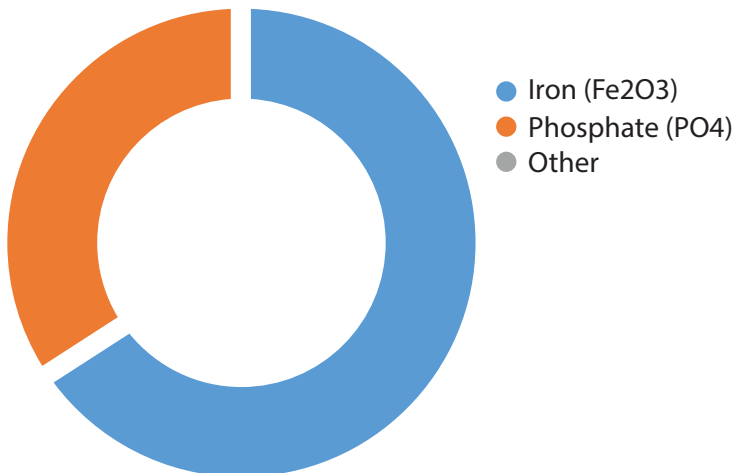
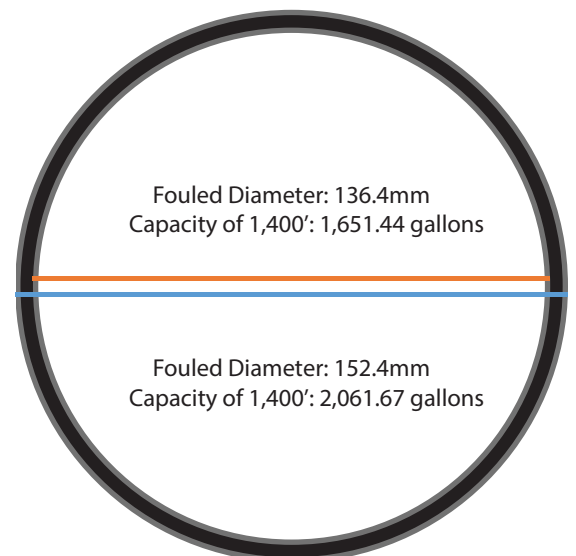
Scale Composition of Second Sample

Due to the severity of the scale accumulation and test results it was recommended that a 100% solution of **RYDLYME** be circulated for at least 8 hours. However, when cleaning began, just 1,650 gallons of **RYDLYME** surpassed the capacity of the digester line. This indicated that there was an average of 8mm of scale deposit throughout the length of the 1,400 foot digester line. Virtually a 60% reduction in volume! After 5 hours of circulation, the flow rate had quadrupled to 6 LPS! However, at this time, the cleaning was paused for visual inspection at a low point in the loop's elevation. Much of the scale deposit remained, so additional samples were collected sent to a third party laboratory for analysis. This second sample deposit was comprised heavily of iron. It was also found that because the circulation loop was not vented to atmosphere, pressure had built up within the pipe and trapped air in the top section of the pipe diameter preventing the scale from being dissolved. The circulation loop was adjusted to incorporate a balancing tote and vent the solution to atmosphere. Upon continuing the circulation, additional volume was realized and all 12 totes of **RYDLYME** were able to be added to digester line. Achieving a system capacity of 3,960 or 96.3% of calculated physical volume. The circulation continued for a total of 90 hours, until the pH had recovered to nearly 5. When the final inspection occurred, there were leftover insoluble particles and grit which were also found in the balancing tote.
